Central Coast Council

Mannering Park Shared Pathway Feasibility Study

July 2017

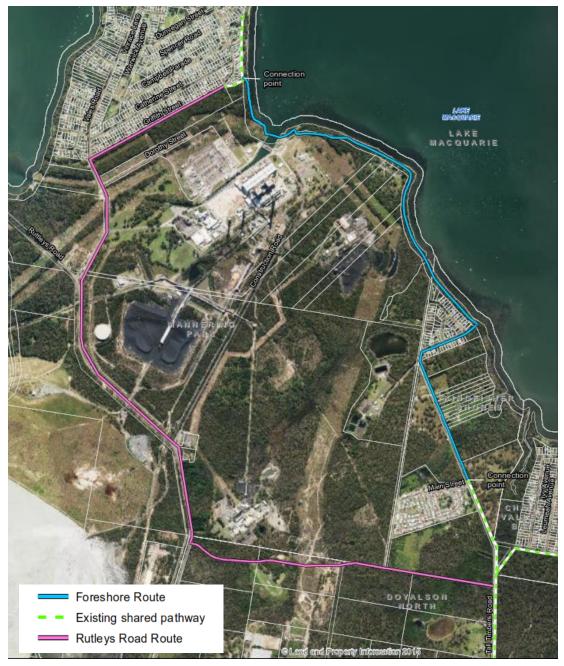
Figure 1-2 Proposed routes

These are highlighted in Figure 1-2 below.

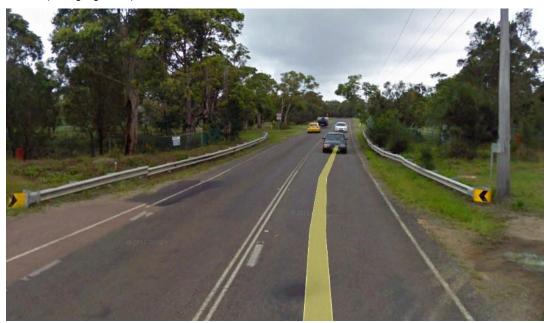
Photo 19 Northern conveyor overpass on Ruttleys Road

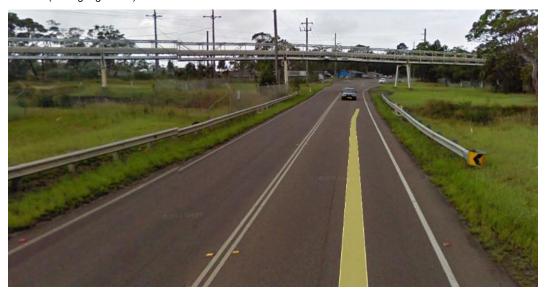
Photo 21 Existing conveyor crossing Ruttleys Road

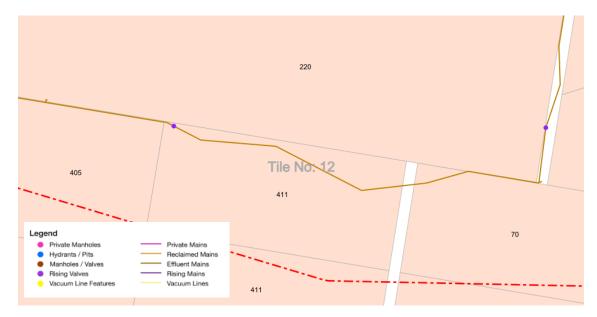
Figure 5-2 Reclaimed water main through Model Aero club off road section

Due to the proposed use of, or crossing of, a number of service maintenance access routes, detailed consideration of maintenance access will be required in the concept phase. The proposed modifications to maintenance access are likely to be a key discussion point in consultation with each asset owner.

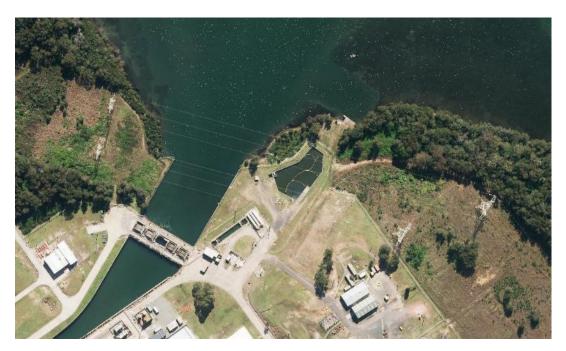
Figure 5-3 View of existing 330kV Overhead towers and cables in vicinity of proposed bridge

- Overhead towers and cables at proposed bridge (see Figure 5-3)
- Transmission tower at edge of foreshore (see Figure 5-4)

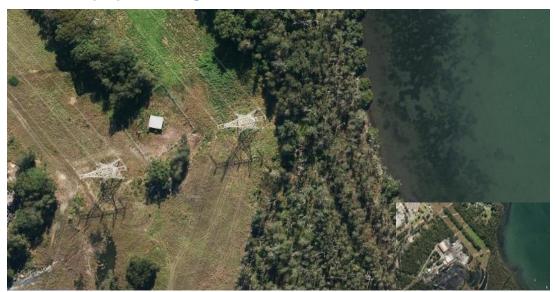
Figure 5-4 Transmission tower at edge of foreshore

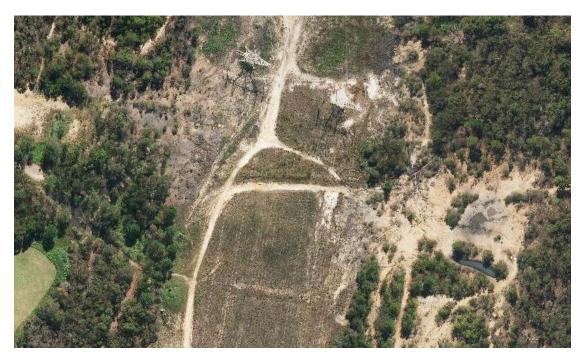
Figure 5-5 Existing 330 kV infrastructure east of Aero club

- Overhead towers and cables east of the Aero club (see Figure 5-5)
- Power poles on the western edge of Ruttleys Road (see Figure 5-6)

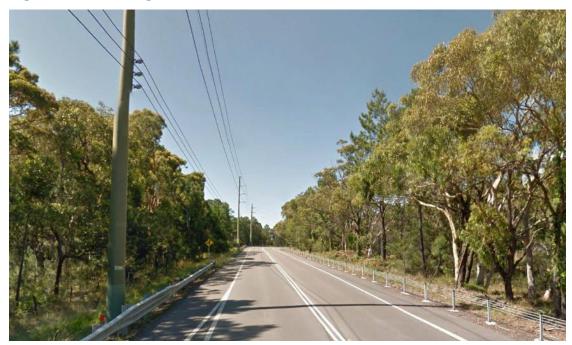
Figure 5-6 View of existing power poles Ruttleys Road

Local narrowing, splitting or deviation of the shared pathways will be necessary at the poles to accommodate the pathway, Figure 5-7 below provides a typical treatment detail for a narrowing treatment.

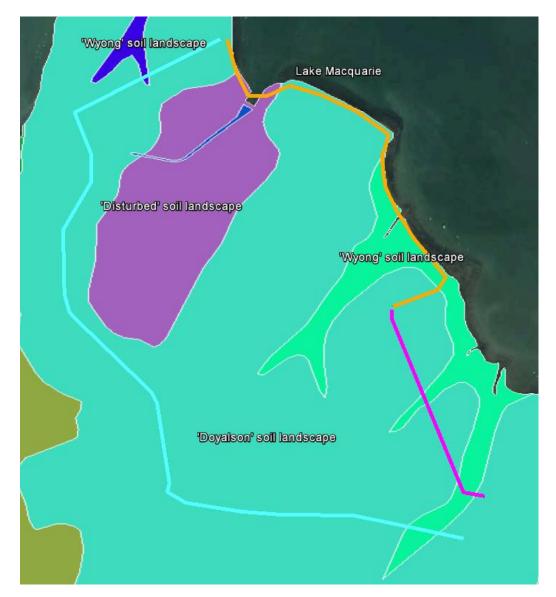
Figure 6-1 Soil landscape areas

The proposed eastern pathway route is expected to traverse through the 'Doyalson' and 'Wyong' soil landscapes, in addition to small areas of 'Disturbed' soil landscapes comprising fill material.

Typical characteristics of each soil landscape are listed below.

- Gently undulating rises on Munmorah Conglomerate with slope gradients less than 10 % and local relief to 30 m
- Predominantly cleared eucalypt open forest with broad crests and ridges and long gently inclined slopes
- Typically moderately deep (0.5 to 1.5 m) soils over sandstone, conglomerate, siltstone
 and claystone, with moderately deep to deep (1.0 to >1.5 m) soils along drainage lines
- Limitations include high erosion hazard, foundation hazard (localised), high run-on (localised), mine subsidence district, seasonal waterlogging (localised), hardsetting, stoniness and strongly acidic soils of low fertility

- Broad poorly drained deltaic floodplains and alluvial flats of Quaternary sediments with slope gradients less than 3% and local relief less than 10 m
- Extensively cleared open forest with meander scrolls, oxbows and swamps
- Soils are typically deep (>2.0 m)
- Limitations include flooding, seasonal waterlogging, foundation hazard, permanent waterlogging (localised), stream bank erosion (localised), acid sulfate potential (localised), strongly acid, poorly drained and impermeable soils of very low fertility with saline subsoils

- Level plain to hummocky terrain that has been extensively disturbed by human activity, including complete disturbance, removal or burial of soil
- Local relief and slopes are highly variable
- Original vegetation has been completely cleared and generally replaced with landfill including soil, rock, building and waste materials
- Limitations are highly variable and may include mass movement hazard, steep slopes, foundation hazard, unconsolidated low bearing strength materials, impermeable soils, poor drainage, erosion hazard, very low fertility and toxic materials

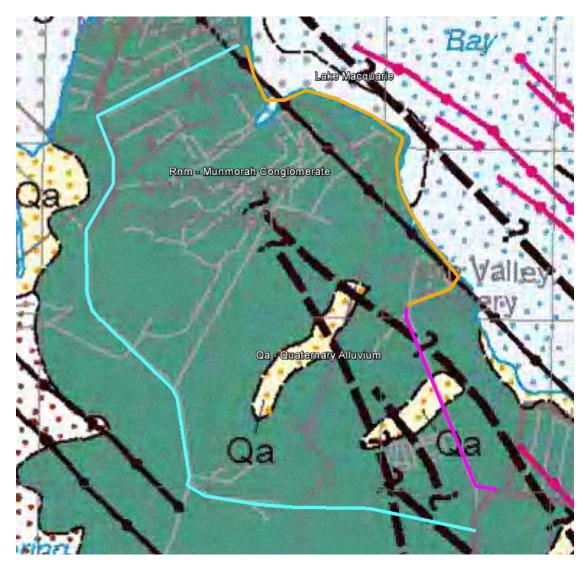
Figure 6-2 Extract showing regional geology areas

A small pocket of Quaternary Alluvium, typically comprising gravel and sand, is expected near the southern extent of the proposed eastern route.

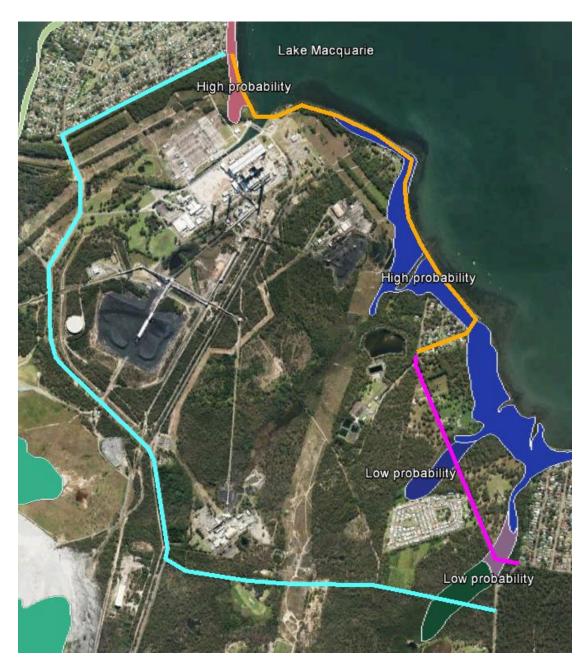
Figure 6-3 Extract showing potential acid sulphate soil locations

Depths to ASS materials in areas of high probability are likely within one metre of the ground surface. Depths to ASS materials in areas of low probability are likely between one and three metres below the ground surface.

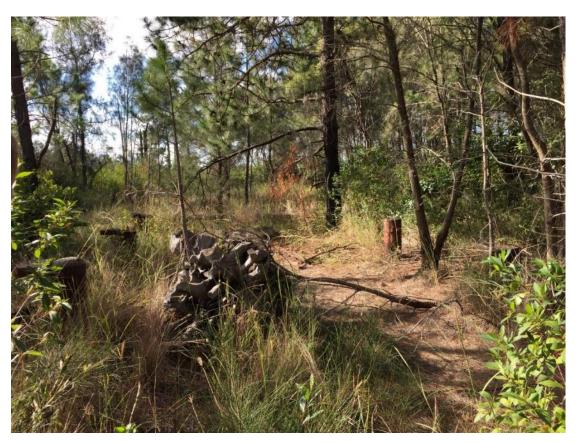
Photo 32 Unidentified waste east of Aero Club (conveyor belt)

Potential Asbestos Containing Material (ACM): No potential ACM was observed during the site inspection. However, there is a potential for ACM to be present in areas where illegal dumping has occurred.	Potential Asbestos Containing Material (ACM): No potential ACM was observed during the site inspection. However, there is a potential for ACM to be present in areas where illegal dumping has occurred.

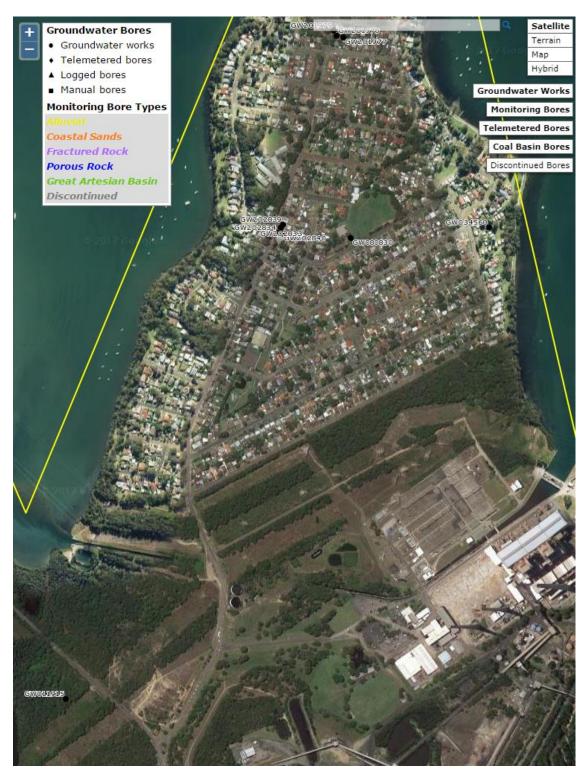
Figure 9-1 Location of Groundwater Bores within close proximity of the proposed pathways

These locations are shown in Figure 9-1 below.

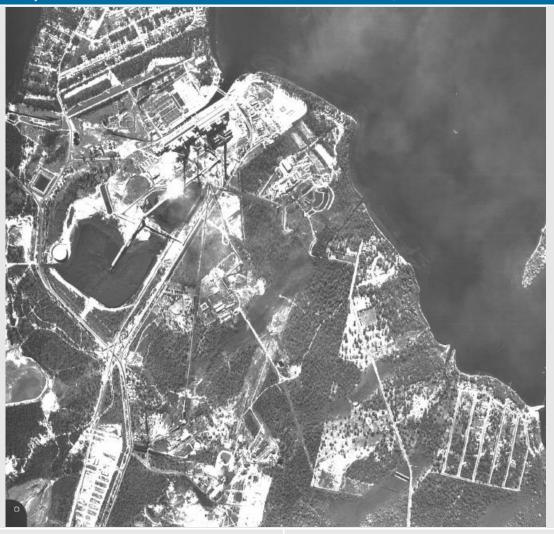
Ruttleys Road Route

Ruttleys Road is visible in its current configuration between the southern portion and Mannering Park. The land immediately adjacent to the road corridor generally consists of access and infrastructure associated with the colliery and power station.

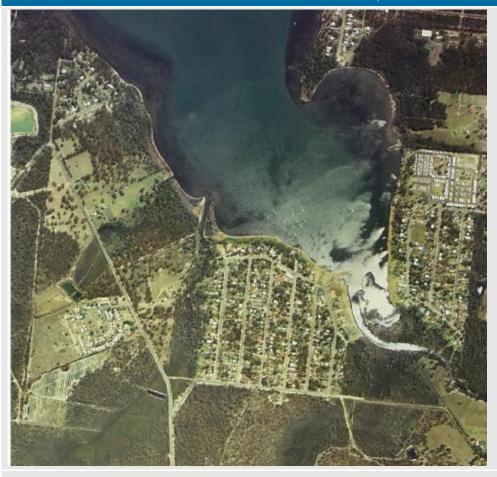
Foreshore Route

The northern part of the proposed pathway is not visible in this aerial photograph.

A sewage treatment plant has been constructed on the western side of Tall timbers Road, opposite the Kingfisher Shores residential area.

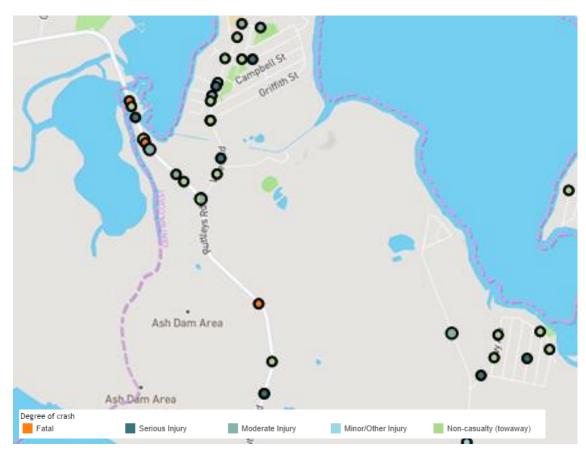
Figure 10-1 Crash Statistics in vicinity of routes

Figure 10-1 below provides information on the crashes in a four year period from 2012 – 2016 which provides an indication of the type of accidents particularly along Vales Road and Ruttleys Road.

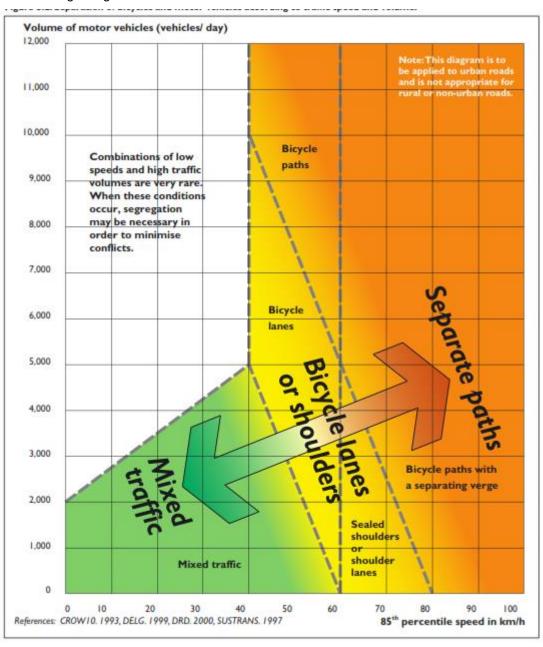
Figure 10-2 Separation of bicycles and motor vehicles according to traffic speed and volume

There is the potential that broader point-to-point cyclists will still be using Ruttleys Road regardless of whether a shared pathway is constructed along the foreshore. The provision of a separated pathway on Ruttleys Road would therefore have the potential to assist more broadly than just catering for cycling movements between Mannering Point and Chain Valley Bay. See Figure 10-2. Traffic volumes however have not been reviewed and this would be undertaken at the next design stage.

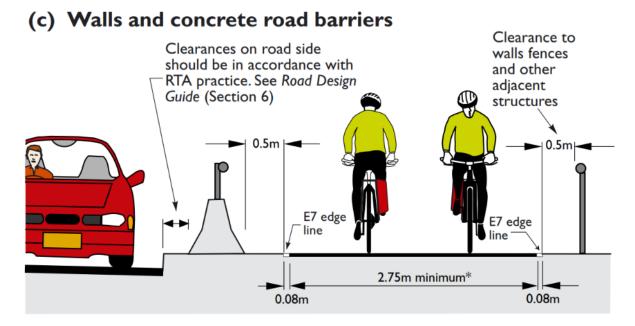
Figure 10-3 Barrier fencing for off-road paths

Figure 10-3 below shows the recommended location of barrier fencing adjacent to roads and other potential hazards.

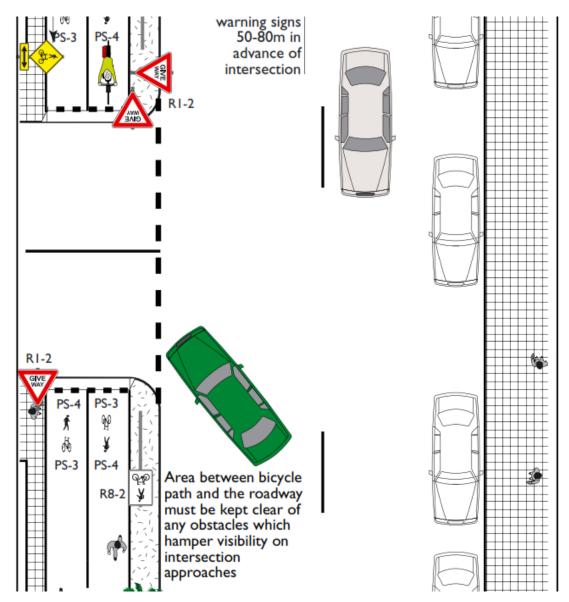
Figure 10-5 Typical intersection detail

Figure 10-5 shows a typical intersection crossing and signage details for a shared pathway.

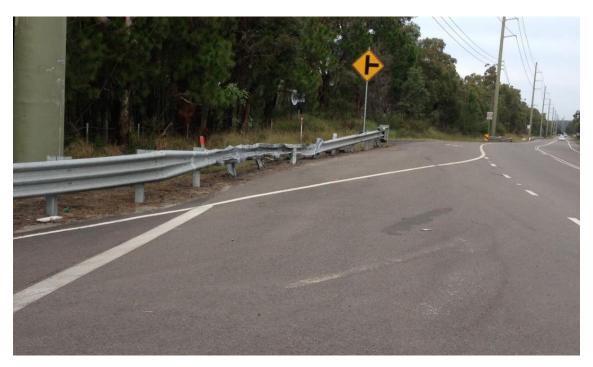
Photo 35 Evidence of recent accident on Ruttleys Road

Subsequent to the meeting Andrew also emailed GHD providing evidence of a recent accident which occurred at the Mannering Park Colliery Site on Ruttleys Road. The intent being to highlight their concerns around the risks of the shared pathway users on Ruttleys Road.

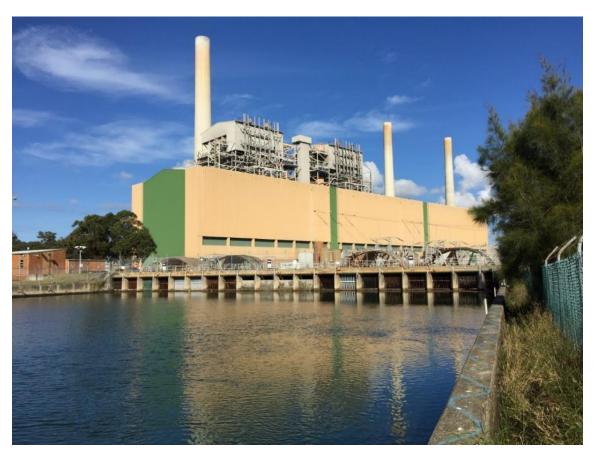
Photo 36 View of existing power station intakes

Concerns were also raised around the bridge at the intakes. This intake creates significant undercurrents into the structure and consideration would be required to prevent people jumping into the water from the bridge or throwing debris into the water, which may damage the intakes.

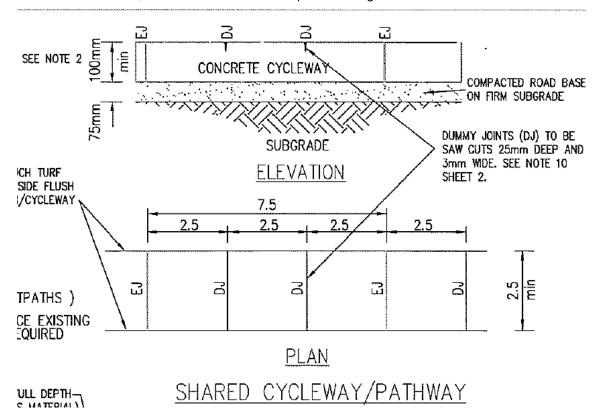
Figure 12-1 Central Coast Council Standard shared pathway construction

Along the road edge the typical path construction would be in the form of a concrete pathway which will be formed, reinforced with mesh and poured using conventional methods.
